# UNDERWATER BRIDGE INSPECTION REPORT

STRUCTURE NO. 73533

CSAH NO. 71

SAUK RIVER

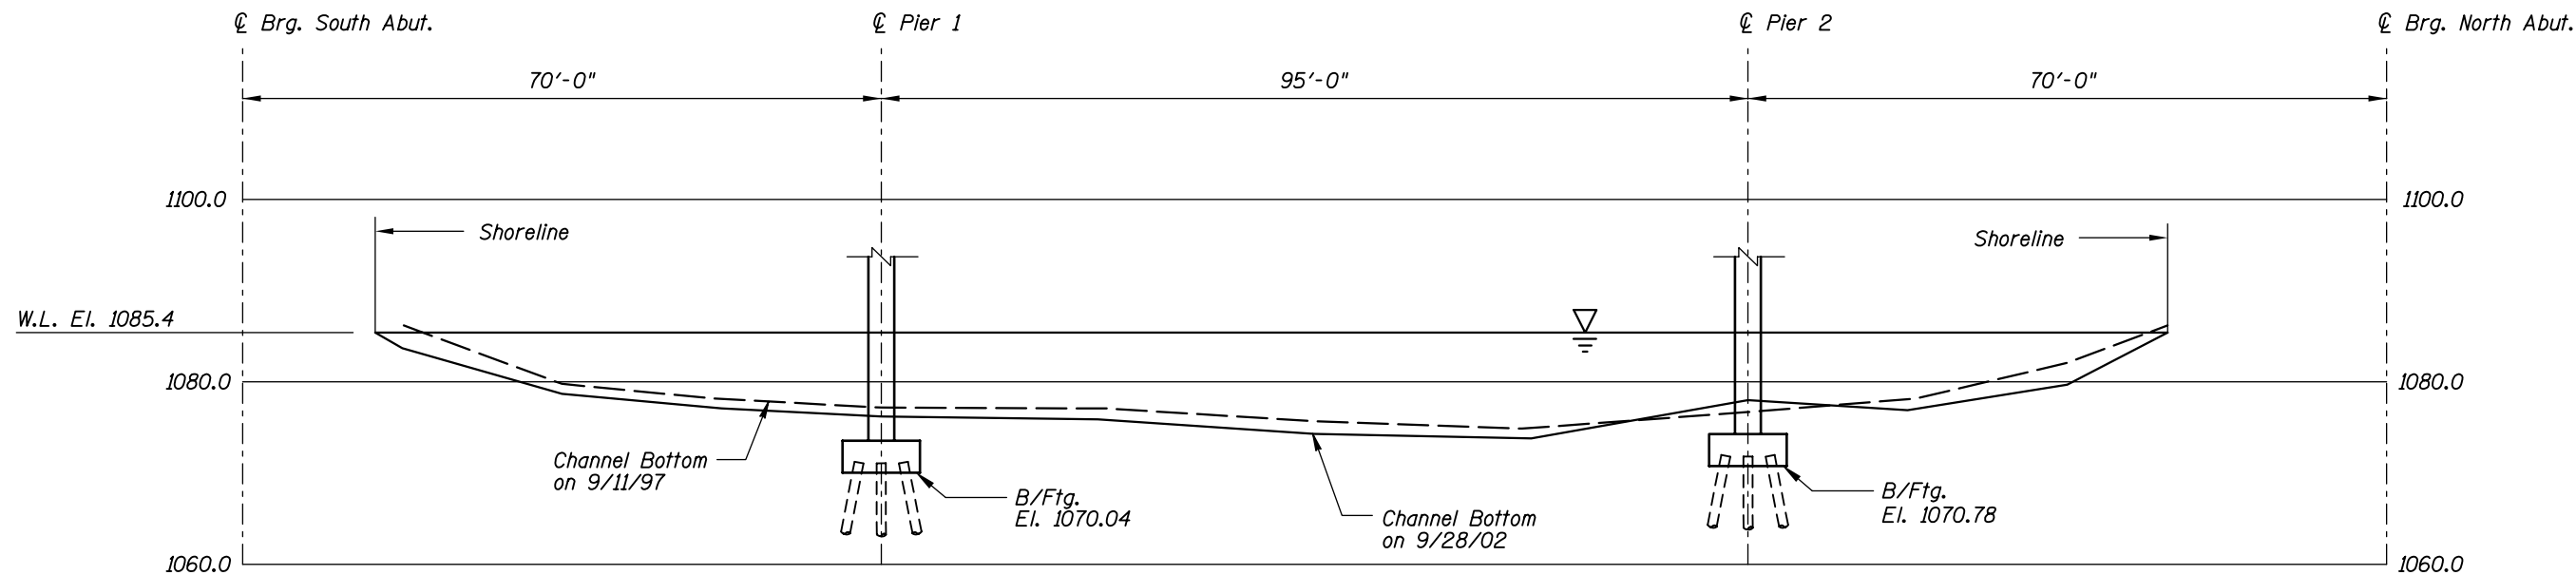
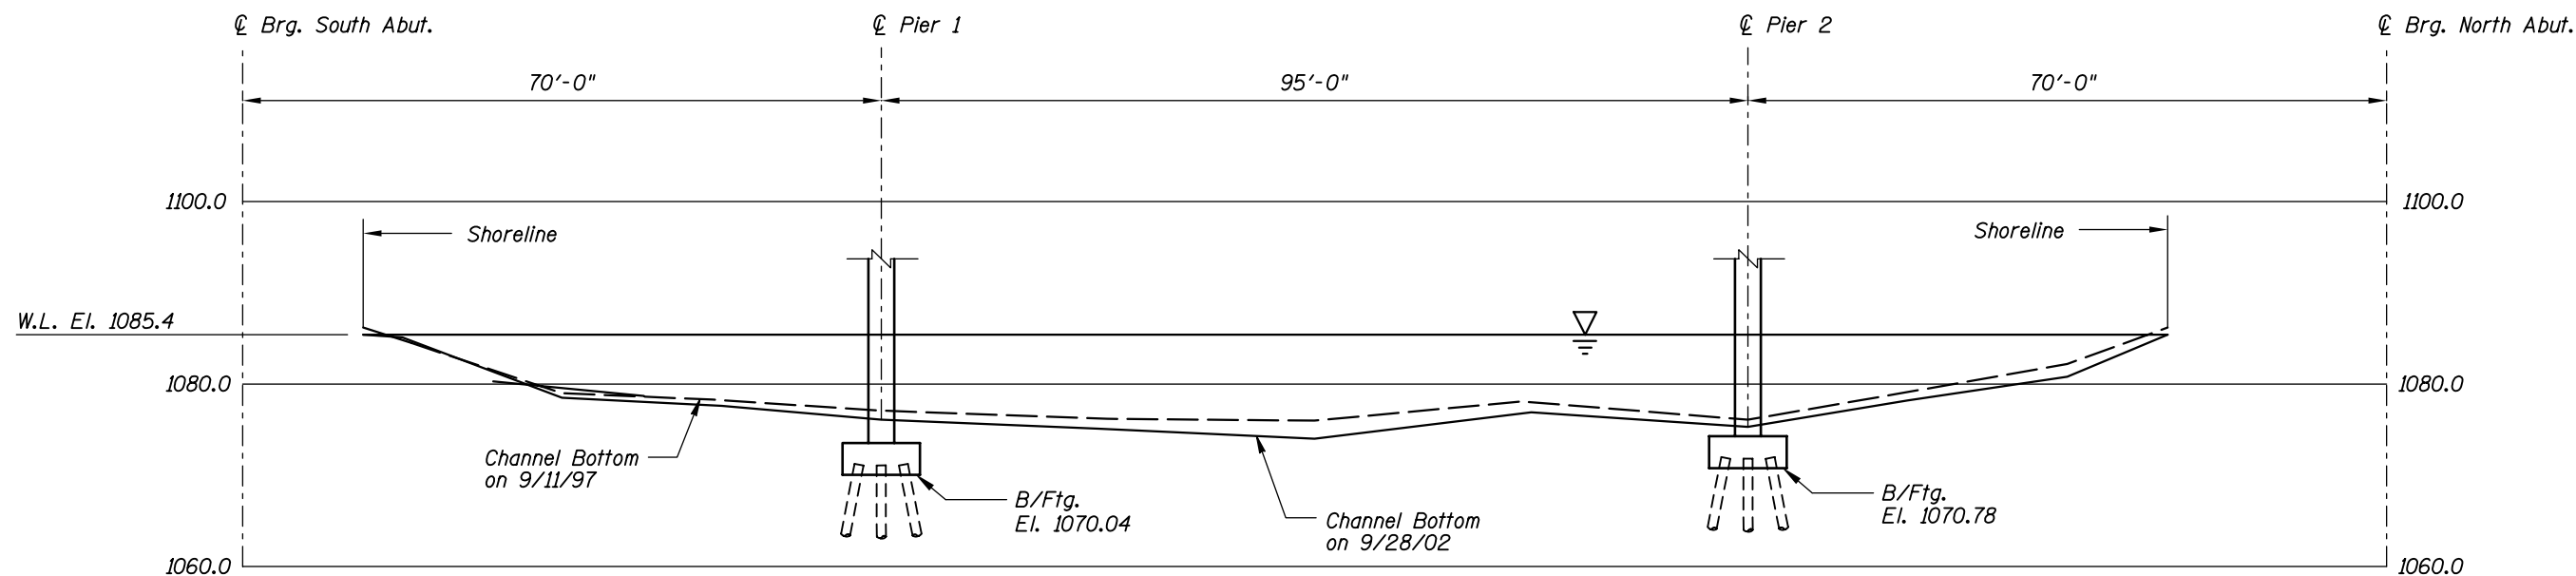
Date: SEPT. 2002  
Scale: 1"=20'  
Figure No.: 2

STRUCTURE NO. 73533  
OVER THE SAUK RIVER  
DISTRICT 3, STEARNS COUNTY  
**UPSTREAM AND DOWNSTREAM  
FASCIA PROFILES**

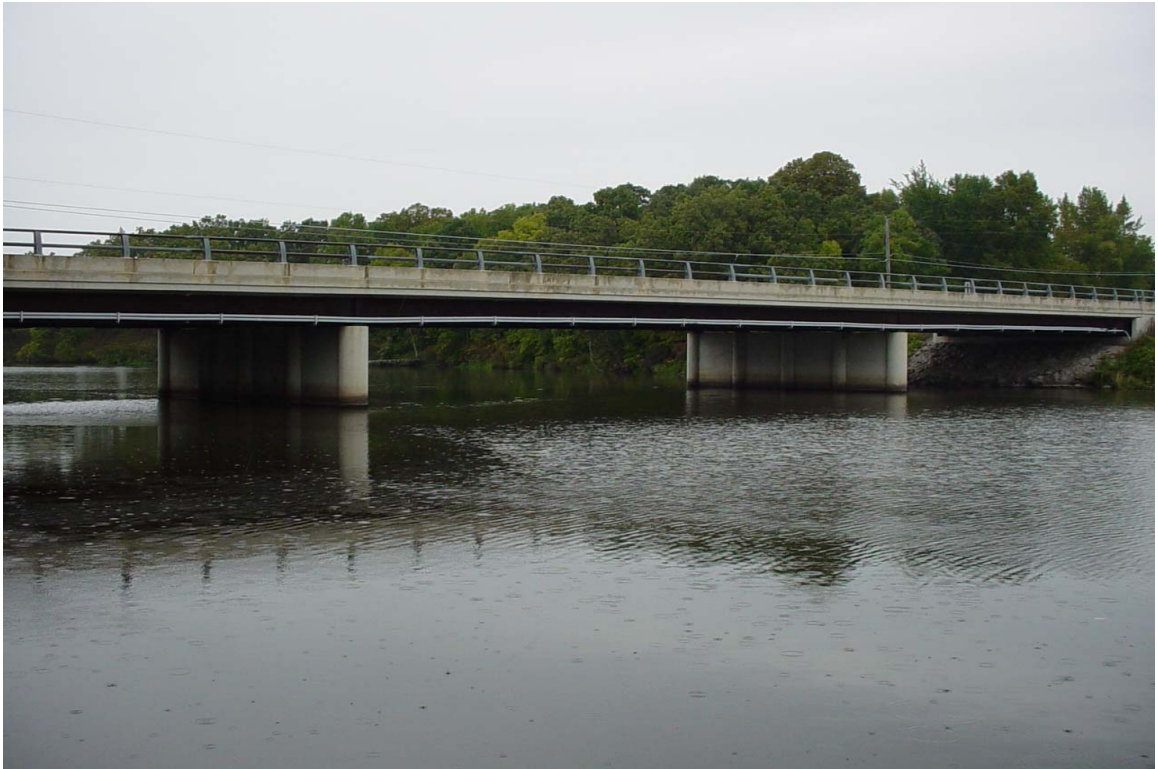
Photograph 1. Overall View of the Structure, Looking Southeast.

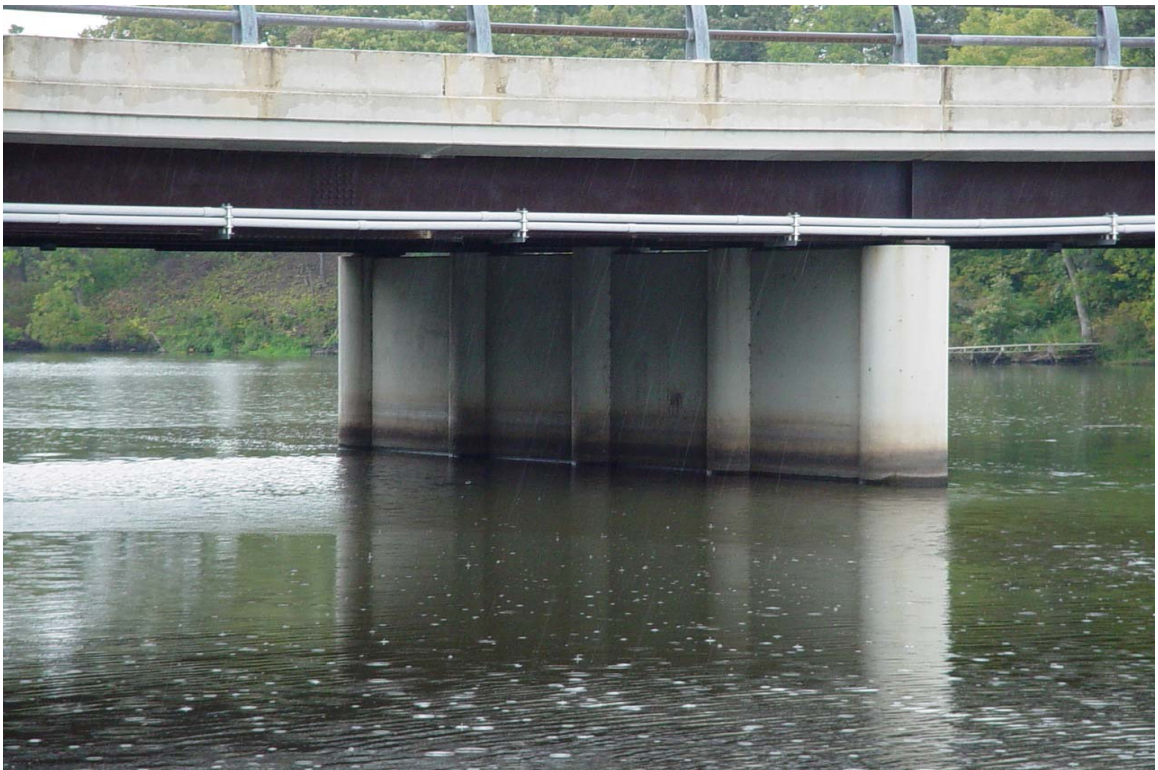
- (A) The concrete of the piers was in good and sound condition with no notable defects.
- (B) A minor accumulation of branchy timber debris was observed along the upstream north side of Pier 2.

Photograph 2. View of Pier 1, Looking Southeast.

- (A) Reinspect the submerged substructure units at the normal maximum recommended (NBIS) interval of five (5) years.

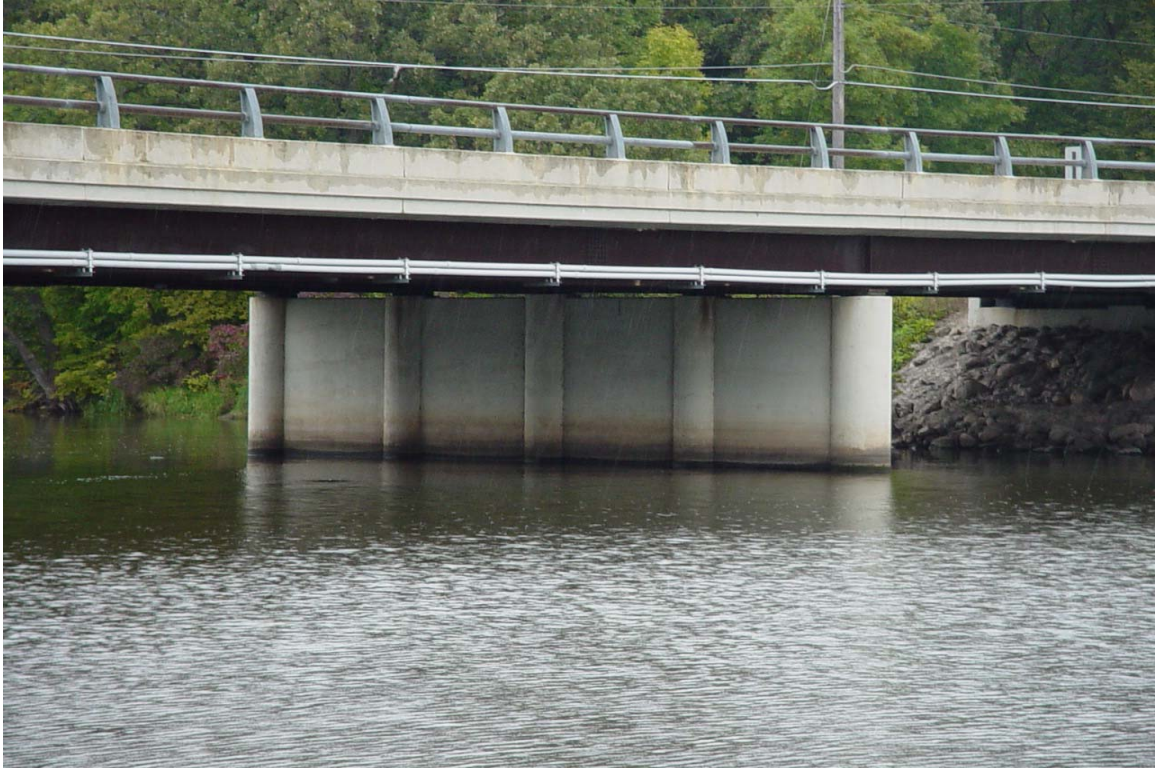
Photograph 3. View of Pier 2, Looking Northwest.
